THE ABANDONED MINE LAND PROGRAM IN NORTH DAKOTA

L. A. Ogaard
Director - AML Division
North Dakota Public Service Commission
State Capitol
Bismarck, ND 58505

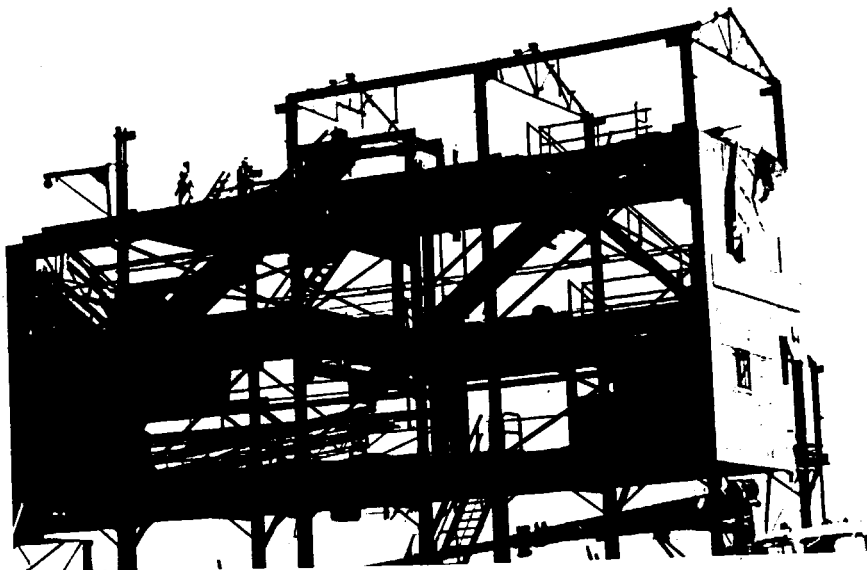
Figure 6. Demolition of Dakota Star tipple, Mercer County, ND.

In the case of a wooden structure, tipple demolition can be accomplished by bulldozing the structure and burning the debris (Figure 5). Tipples constructed of metal beams can be dismantled (Figure 6) using welding torches.

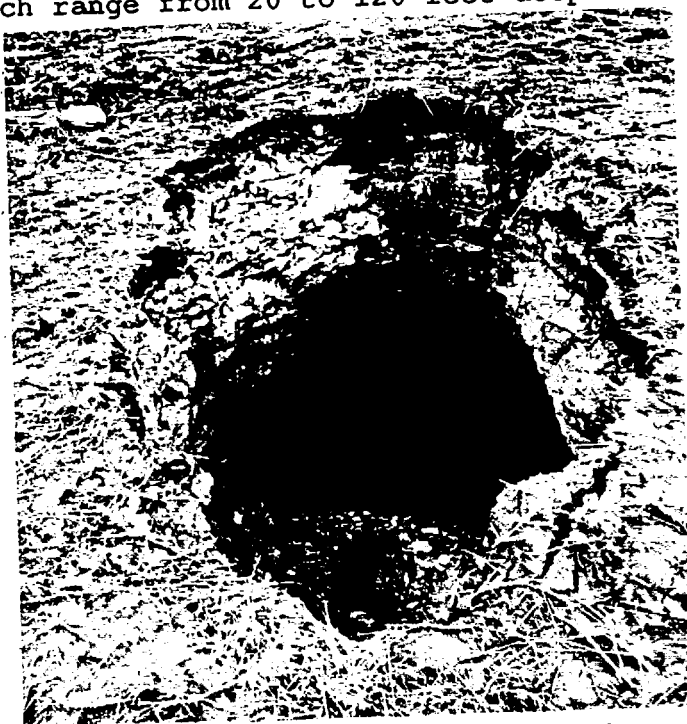
Hazards created from abandoned underground mines are more intractable. Collapse of underground mine workings is manifested at the surface as depressions known as subsidence features. If these depressions are deep enough so that someone who fell in could not climb out they are called "vertical openings" (Figure 7). Vertical openings which directly connect with tunnels are referred to as "shafts", which range from 20 to 120 feet deep.

Figure 7. Vertical opening at Beulah AML site, Mercer County, ND.

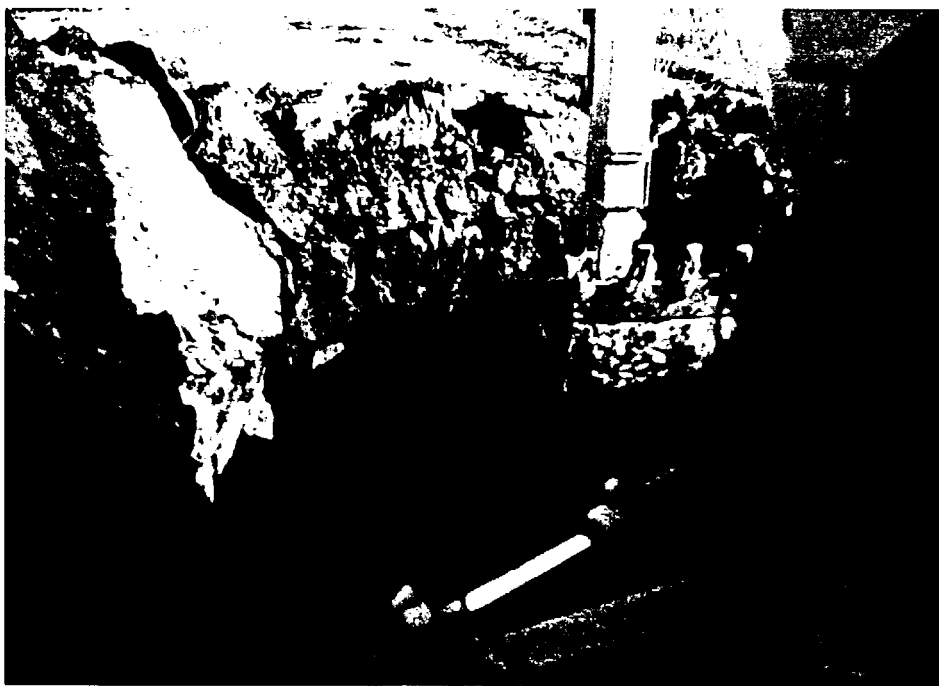
Reclamation of subsided areas can be accomplished several ways. Daylighting (Figure 8), one of the more expensive techniques, involves excavating the underground tunnels and rooms with heavy equipment.

Figure 8. Daylighting at the Scranton AML site, Bowman County, ND.
